Manhole Inspection Summary

Manhole # S13Q__025MH

Insp Date: **3/17/08 10:27 AM**

Location Address: **2900 Kingsley St**

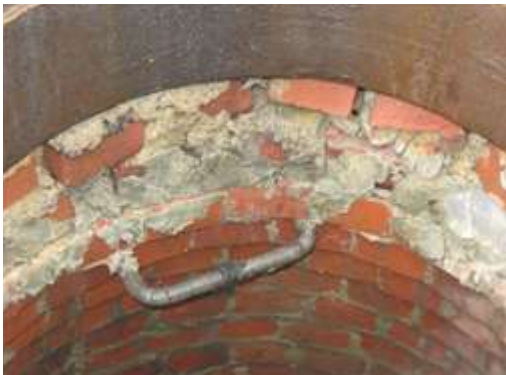
Defect 1

Condition: ☐ Sound ☐ Cracked ☐ Root Intrusion ☒ **Loose Brick** ☐ Deteriorated

Infiltration: ☐ None ☐ Joint ☐ Cracks ☐ Mortar ☐ Roots ☒ **Wall**

chimney loose bricks, signs of infiltration at chimney wall

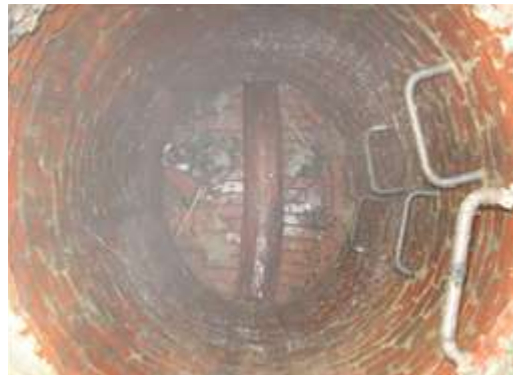
Defect 2

Infiltration: ☐ None ☐ Joint ☐ Cracks ☐ Mortar ☐ Roots ☒ **Wall**

evidence of corbel and barrel infiltration at wall

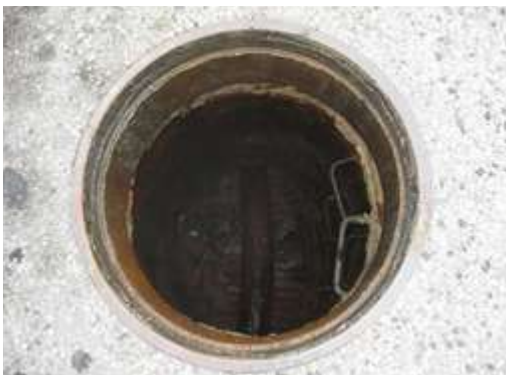
Defect 3

Frame Offset: **0** (in.) Condition: ☐ Sound ☐ Cracked ☒ **Leaks**

frame leaks

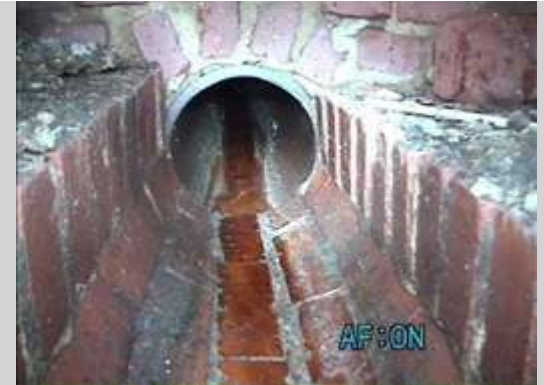
12 O'Clock Outflow

8 in. Circular Gravity Sewer
Pipe Out @ 12 O'Clock

Infiltration: **None** Pipe Seal Cond: **Sound**

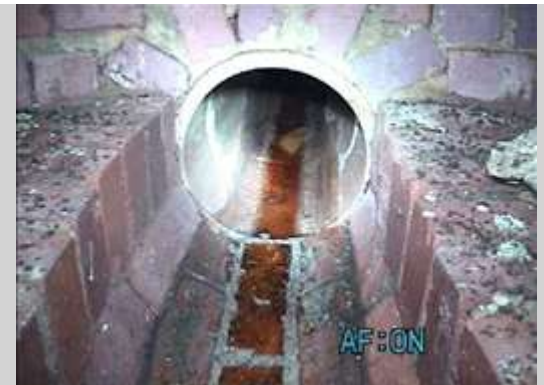
6 O'Clock Inflow

8 in. Circular Gravity Sewer
Pipe In @ 6 O'Clock

Infiltration: **None** Pipe Seal Cond: **Sound**
